Hunters Dam Site

Photo 30. Aerial view of Hunters Dam site (Owens Component) and drill holes

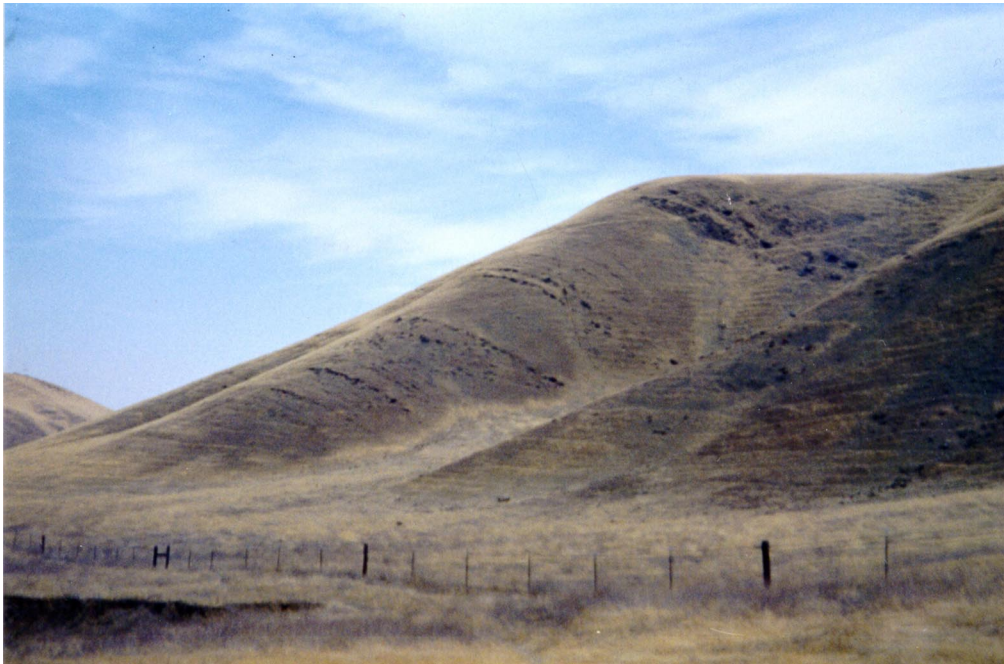
The majority of the dam foundation is composed of interbedded Upper Cretaceous sandstone and mudstone of the Boxer and Cortina Formations, forming a ridge that extends the length of the dam site (Photo 31). The foundation bedrock consists of about 65 percent mudstone and 35 percent sandstone.

Photo 31. Boxer/Cortina Formation contact on ridge just SW of Hunters component.

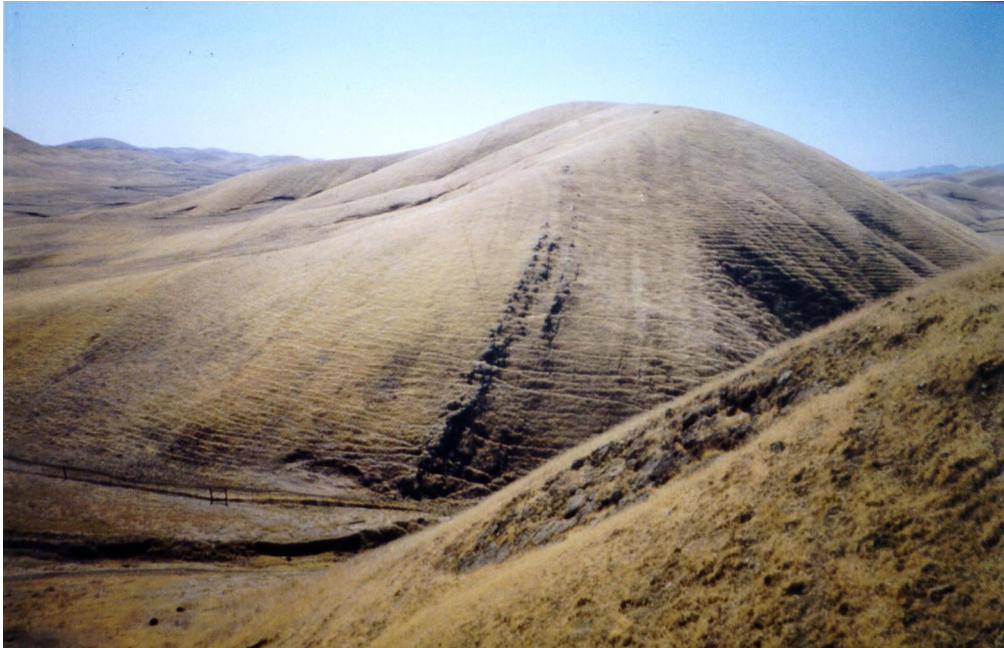
The primary structural feature at the Hunters Dam site is the northerly striking, east-dipping homoclinal bedding of the Great Valley sequence (Photo 32). Local attitudes vary in strike from N3°W to N15°W and bedding dips in an eastward direction, mostly from 45 to 55 degrees at the south end to 55 to 65 degrees at the north end.

Photo 32. Southern view of the Hunters component of Hunters Dam site

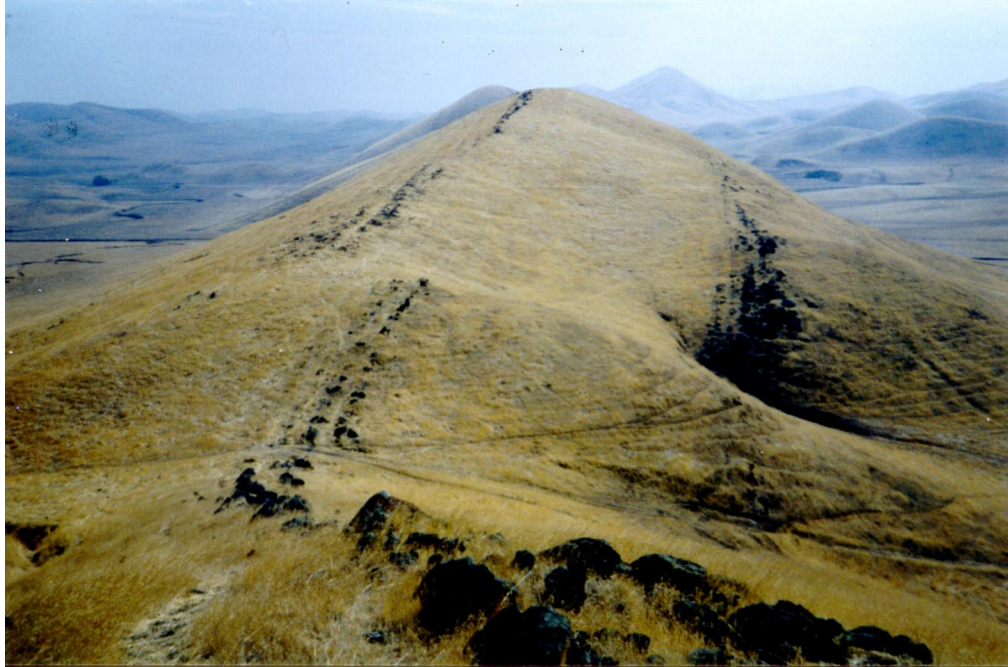
A second lineament crosses the dam alignment about a quarter of a mile north of the Hunters Creek water gap (Photo 33). The lineament trends southwest to northeast. If this lineament is a fault, the sense of movement would be right lateral, with an apparent offset of the Boxer/Venado contact and the second major sandstone in the Venado of about 150 feet; and the fault plane would be near vertical.

Photo 33. Lineament truncating sandstone beds north of Hunters component

About 2,400 feet north of the Hunters Creek gap the ridge is crossed by a lineament that offsets the Boxer/Cortina contact to the right about 150 feet. This feature has not been drilled or trenched to establish its true character. At least one spring associated with this lineament is within the dam footprint.

- Map the dam site, especially two other major components, i.e., Hunters and Prohibition, in more detail.
- Drill and water pressure test Hunters and Prohibition.
- Drill and trench the two potential faults.

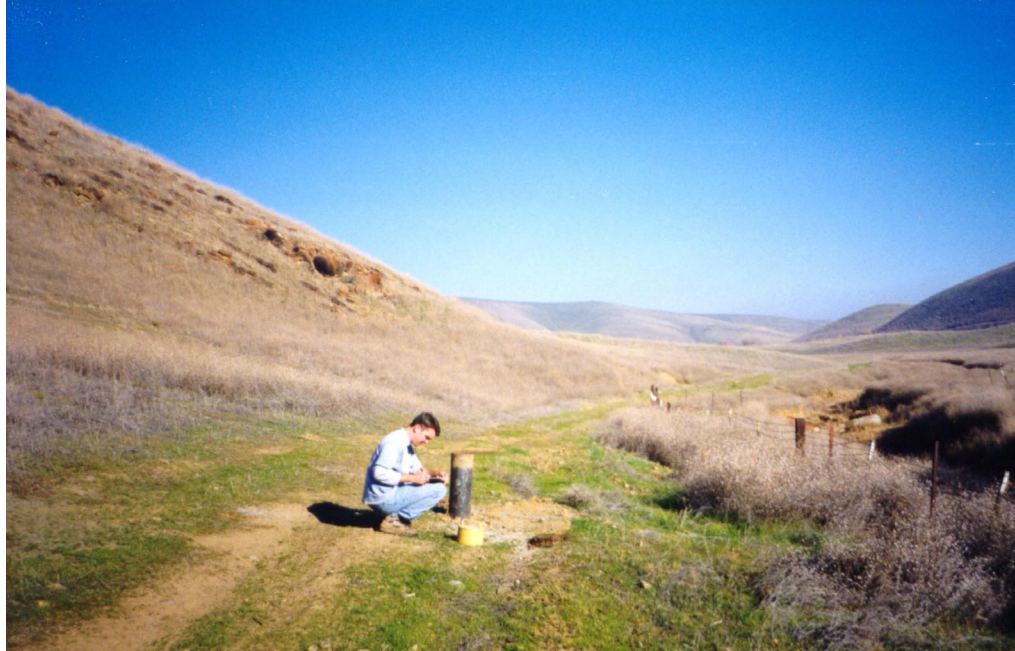
Vertical drill hole LC-1 was drilled in the drainage gap at the Owens component. It was drilled to a total depth of 203.3 feet. The upper 23.6 feet were augered through terrace deposits on the floor of the gap. There was no recovery from 23.6 to 28 feet. From 28.0 to 68.5 feet, the hole drilled through thickly bedded siltstone. From 68.5 to 88.3 feet, the hole drilled through 50 percent sandstone and 50 percent mudstone interbeds. From 88.3 to 110.5 feet, the hole drilled through 90 percent mudstone with 10 percent sandstone interbeds. From 110.5 to 123.3 feet, the hole drilled through 90 percent sandstone with 10 percent mudstone interbeds. From 123.3 to 163.5 feet, the hole drilled through 80 percent mudstone with 20 percent siltstone. From 163.5 to 173.3 feet, the hole drilled through 50 percent siltstone and 50 percent mudstone; and from 173.3 to 203.3 feet, the hole drilled through 80 percent mudstone and 20 percent siltstone. The hole encountered minor fractures and shears at 86.3 and 86.6 feet, and fractures with slickensides at 150.8 to 151.8 feet.

In drill hole LC-1 permeabilities are high, averaging 0.52 feet per day in the top 76.7 feet of this drill hole, indicating pervious conditions. Weathering and fractures along bedding planes account for these high values. Associated grouting requirements are also high in this zone, Lugeon values ranging from 23 to 34. From 76.7 feet to the bottom of the hole at 203.3 feet, semipervious to impervious permeability conditions exist. Lugeon analysis indicates dilation type patterns throughout this portion of the hole, which is regarded as a temporary feature, and no grouting required.

Owens component drill holes LC-1, LA-1, RC-1 and RA-1 had piezometers placed in them after drilling. Water levels have been monitored since summer 1998. Water surface elevations in LC-1 varied from 255.6 feet (July 1999) to 259.6 feet (November 1998) (Photo 34). Water surface elevations in LA-1 varied from 430.6 feet (July 1999) to 452.4 feet (September 1999) (Photo 35). Water surface elevations in RC-1 varied from 251.4 feet (September 1999) to 254.3 feet (March 1999) (Photo 36). Water surface elevations in RA-1 varied from 421.7 feet (November 1999) to 425.1 feet (November 1998).

Photo 34. Vertical drill hole LC-1 of Owens component

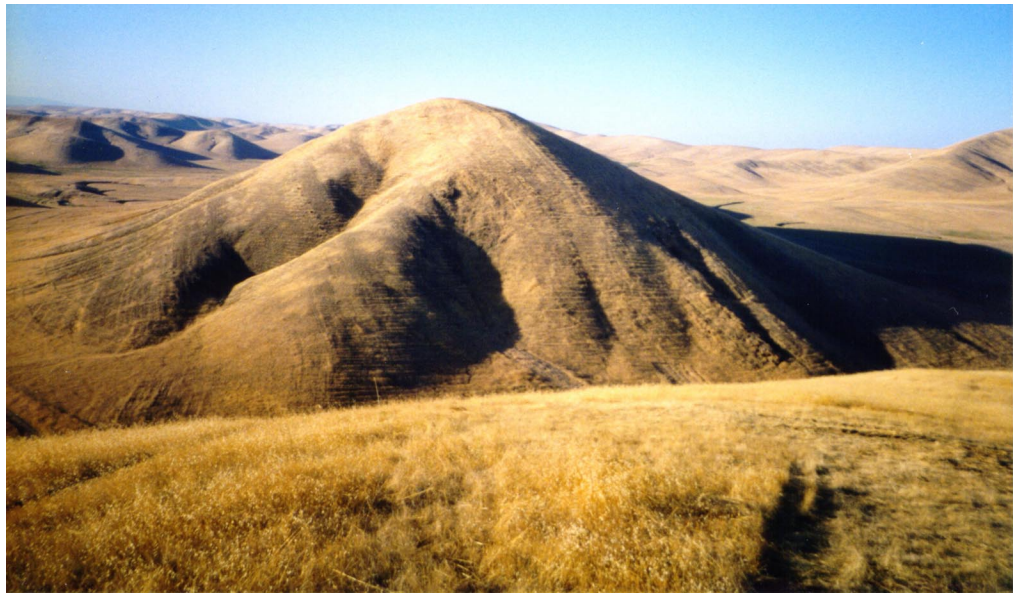
At the Owens gap the left abutment is very steep to about elevation 480 feet before it begins to flatten. A massive sandstone unit is exposed along the downstream face. The right abutment slopes steeply to about elevation 400 feet. The bedding strikes N7°W and dips 50 to 65 degrees east. The dominant joint direction is about east-west and dips 65 to 87 degrees south. A secondary joint set strikes north-west and dips 35 to 55 degrees west.

Some sheared rock has been observed on the face of the left abutment, but no displacement has been observed in this area.

Photo 35. Northern view of left abutment of Owens component

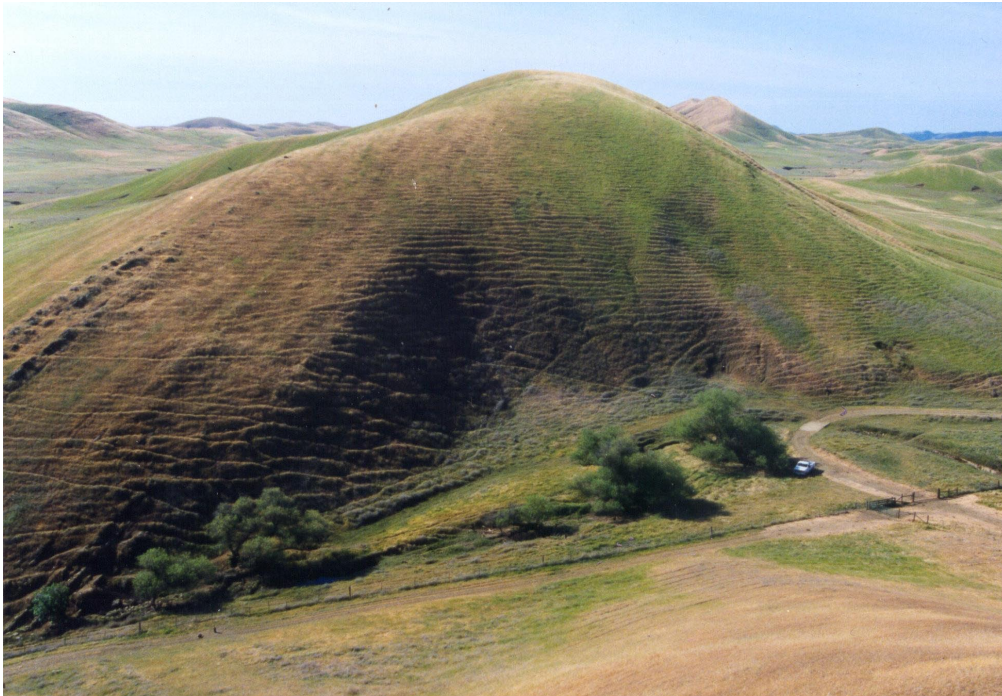
Photo 36. Southern view of right abutment of Owens component

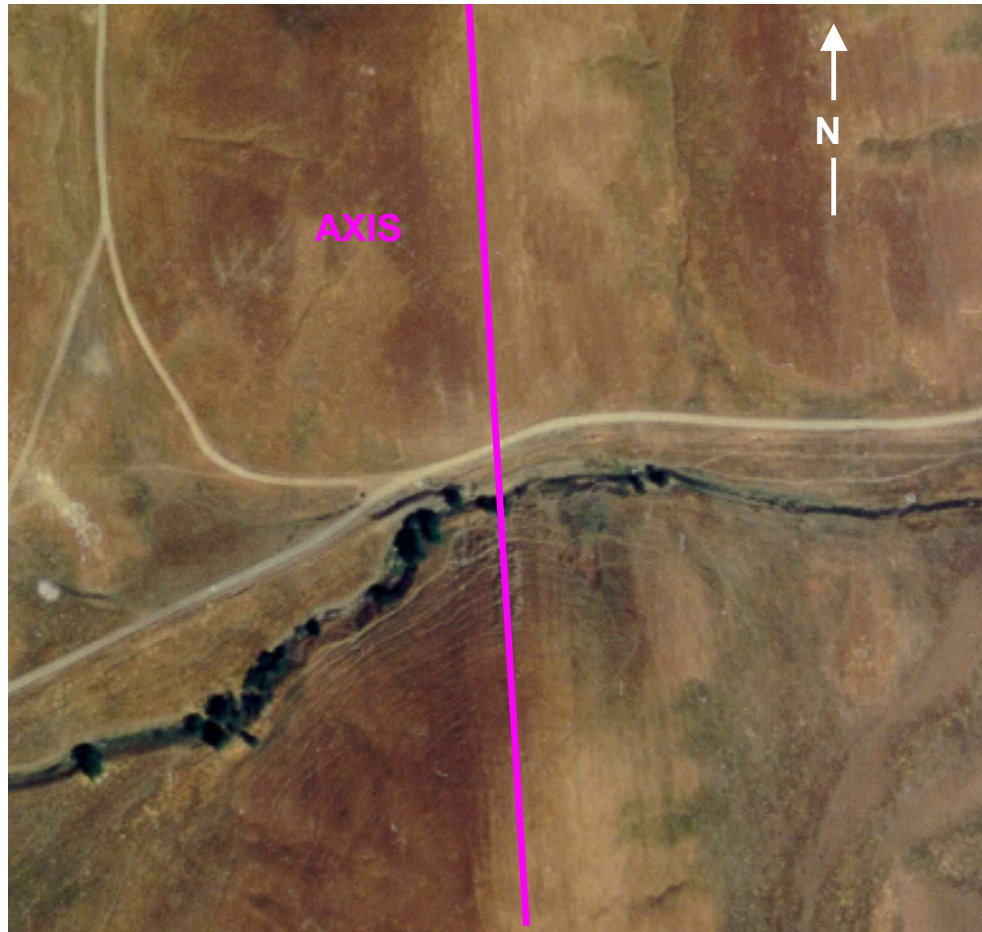
At the Prohibition gap the left abutment has a moderate slope to an elevation of 400 feet then flattens along the ridgeline to the north (Photo 37). The right abutment slopes steeply to an elevation of about 480 feet before the slope flattens. A massive sandstone unit underlies both ridges. The beds strike N7°W and dip 50 to 55 degrees to the east. The dominant joint direction is about east-west and dips 75 degrees south. There are several minor landslides on the upstream side of the right abutment, and the largest landslide mapped, with up to three episodes of movement, occurs on the downstream side of the right abutment.

Photo 37. Aerial view of Prohibition component of Hunters Dam site
